Manhole Inspection Summary

Manhole # S71S__002MH

Insp Date: **4/18/08 10:35 AM**

Location Address: **6700 Railway Ave.**

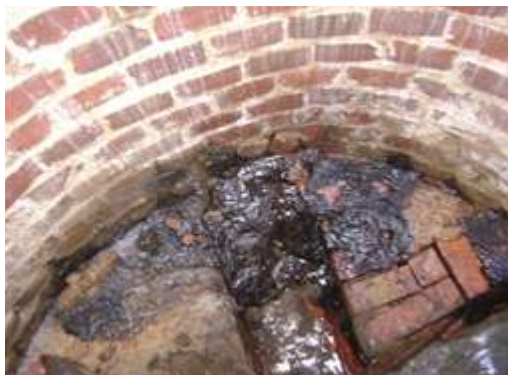
Defect 3

Infiltration: ☐ None ☐ Joint ☒ **Cracks** ☐ Mortar ☐ Roots ☒ **Wall**

infiltration at bottom of barrel wall and abandoned incoming 6 o'clock line

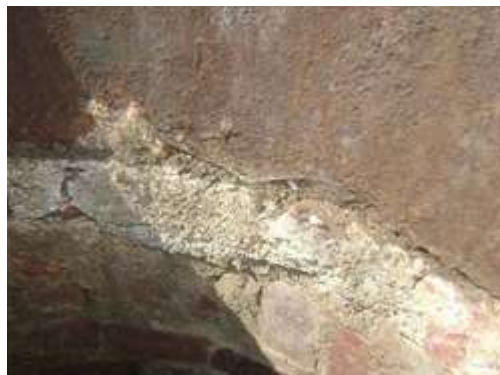
Defect 1

Condition: ☐ Sound ☐ Cracked ☐ Root Intrusion ☐ Loose Brick ☒ **Deteriorated**

previous parging at frame adjustment

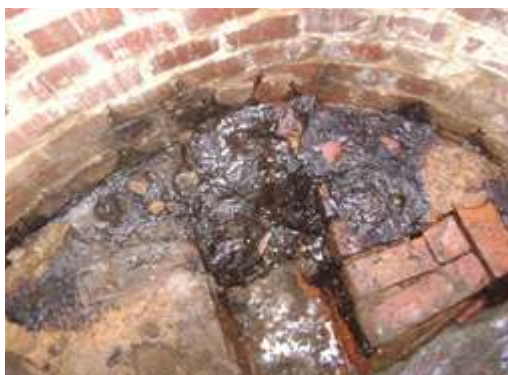
Defect 3

infiltration @ blocked pipe

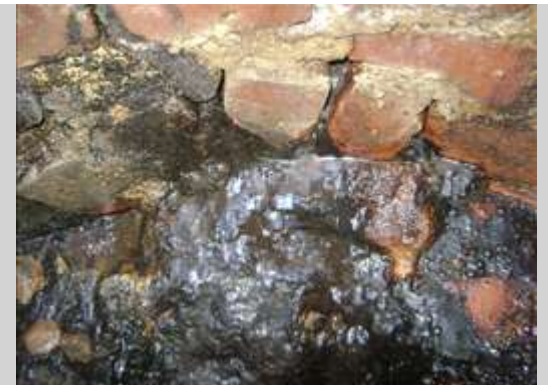
6 O'Clock Inflow

Pipe Height: (in.) Direct
Pipe Material: **Clay** ☐ Pipe Lined
Invert Depth: **8.40** (ft.) Flow Characteristics: **None**
Deposits: ☐ None ☒ Mud ☒ Sludge ☒ Debris ☐ Grease
Silt Depth: **8** (in.) Deposits Extent: **Heavy**
Infiltration: **None** Pipe Seal Cond: **Unknown**

Connects To: **Stub connection / abandoned**
